NPFVOA

Issue No. 118
Fall 2023

VESSEL SAFETY PROGRAM

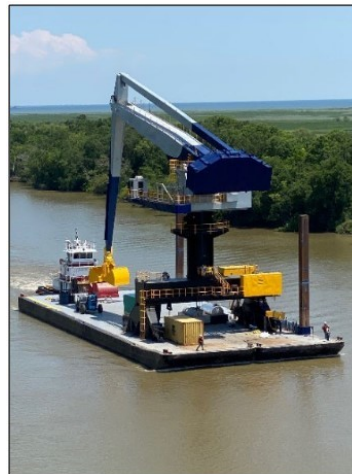
Fig 1: Barge with crane loaded on board.

A recent marine casualty resulting in the total loss of a crane barge, estimated at over 6 million dollars, is a stark warning of the risks involved with failing to adhere to load line regulations. The incident occurred approximately 18 miles offshore of Louisiana in the Gulf of Mexico while the crane barge was being towed in calm weather conditions. The barge was uncertificated without a load line and the operator did not request a Single Voyage Load Line (SVLL) Exemption from any Coast Guard unit before transiting beyond the Boundary Line. The Boundary Line is stipulated in 46 CFR Part 7, and non-load line vessels operating outside the Boundary Line are subject to penalties and fines stipulated in 46 USC 5116.

Over the course of the investigation, the Coast Guard discovered major modifications to the barge arrangement and other conditions which compromised its seaworthiness. This would have precluded issuance of a SVLL exemption until corrected. Additionally, prior to capsizing, the vessel made multiple voyages outside the Boundary Line without a load line, violating U.S. statutory requirements and placing the vessel and crew at risk.

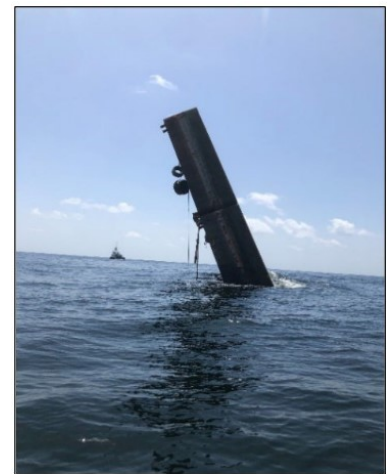
Fig 2: Barge after capsizing.
